DAM INSPECTION CHECKLIST **POSSUM POINT POWER STATION** **POND ABC**

INSPECTION DATE: 5/13/15

INSPECTED BY: D. West, K. Homza

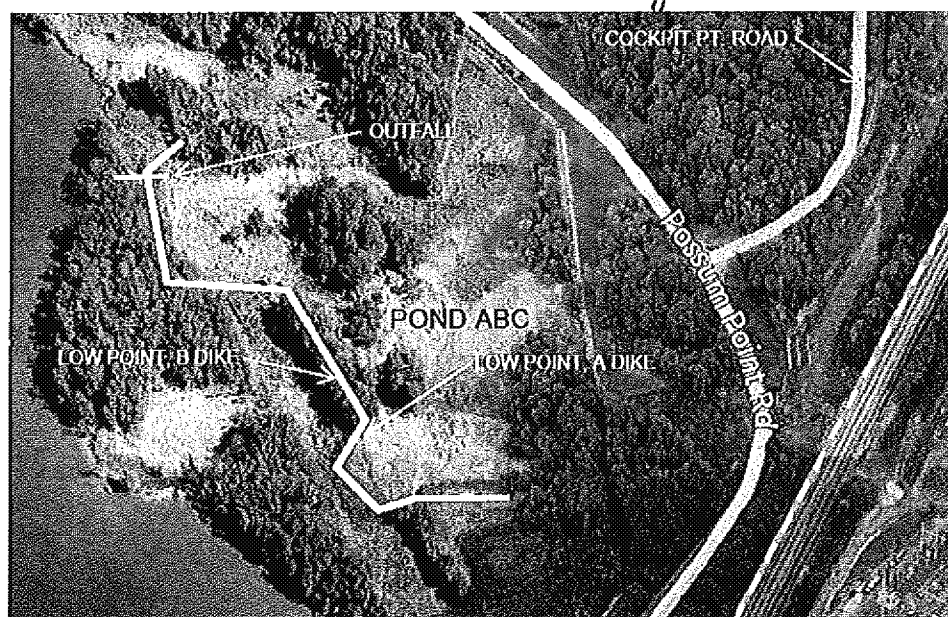
* See figure below.

Location/ Condition	(y/n)	Change (y/n)	Comments
Low Point, A dike*			
Flow	N	N	0810 hrs. Standing water along perimeter of pond
Erosion	N	N	new road. Standing water behind sandbags. No flow or seep under sandbags.
Low Point, B dike*			
Flow	N	N	0815 hrs. No standing water. Sand bags and
Erosion	N	N	rip rap in place.
Outfall			
water surface El. (top of stoplogs to water)			0817 hrs. Standing water behind sandbags. Standing water behind concrete weir structure. No flow or seep at the discharge pipe. 44' 1/2".
